TMS
DISASTER INVESTIGATION REPORT

***PERFORMANCE OF MASONRY STRUCTURES
IN THE NISQUALLY, WASHINGTON
EARTHQUAKE OF
FEBRUARY 28, 2001***

**A Report by the Disaster Investigation
Reconnaissance Team of TMS**

December 2001

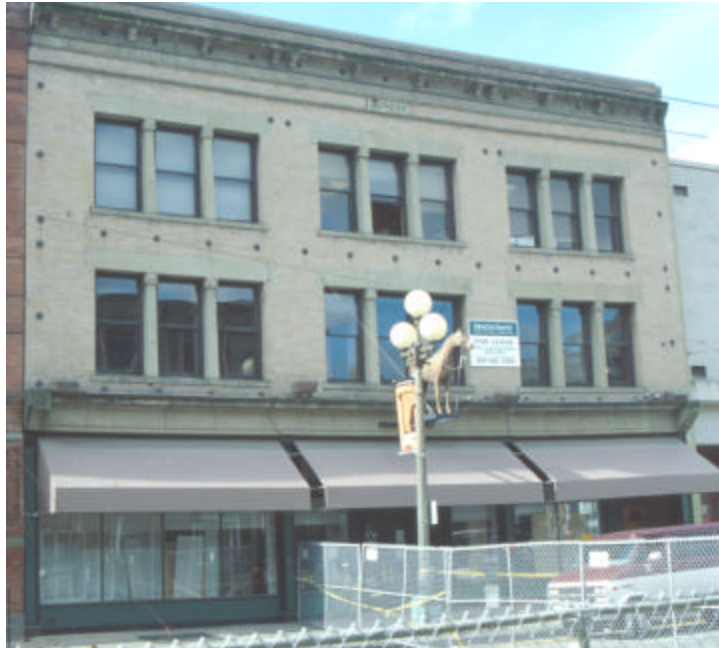
The significant damage observed in the Seattle area was confined to the downtown area, which has older URM structures founded on saturated fill material. The Pioneer Square area in downtown Seattle is located just adjacent to the waterfront (Figure 3). The area was filled and developed in the late 1800's and early 1900's. Consequently, there is a concentration of 2- to 5- story residential and commercial URM buildings in Pioneer Square and south downtown (SoDo) Seattle. A few of the structures observed carried historical markers indicating construction dates near the turn of the century. Seattle does not have mandatory strengthening requirements for URM buildings. However, several of the URM buildings observed appeared to have been strengthened with roof and floor ties as evidenced by regular patterns of anchor ends visible on the exterior (Figure 4).

Figure 4. Floor and roof ties in strengthened URM structure.

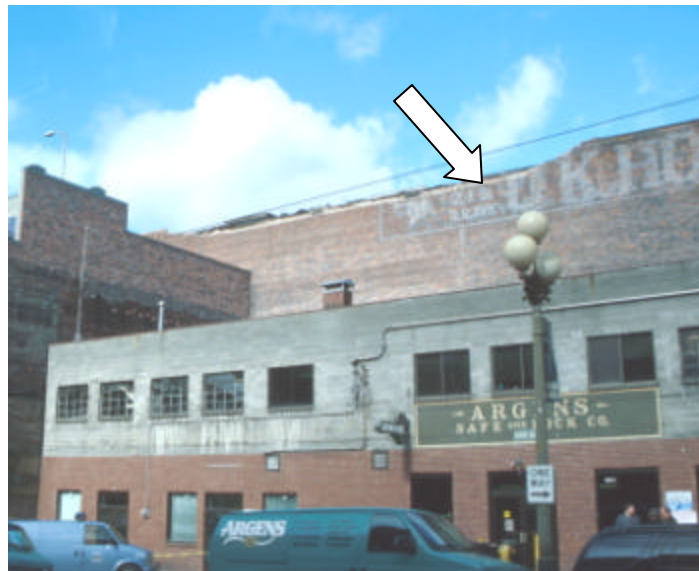
The URM damage patterns observed during the investigation were typical of damage encountered in this type of construction. The most common damage observed was that of falling parapets that were unbraced (Figure 5). More severely damaged URM structures had lost entire upper sections of bearing walls. Many of the older URM bearing wall buildings have timber roof and floor framing. The flexible roof and floor diaphragms undergo large displacements during shaking, which can cause significant outward forces on the URM walls, particularly at the midspan of the roof and floor diaphragms. Figure 6 shows buildings in which the bearing walls appear to have been pushed out at approximately the middle of the building. Damage was also noted in URM elements between openings (Figure 7). Most of the pier damage noted was that of diagonal cracking primarily following the mortar joints. Evidence of corner separation and hammering between structures was noted (Figure 8 and Figure 9).

Figure 5. Loss of unbraced parapet in URM building.

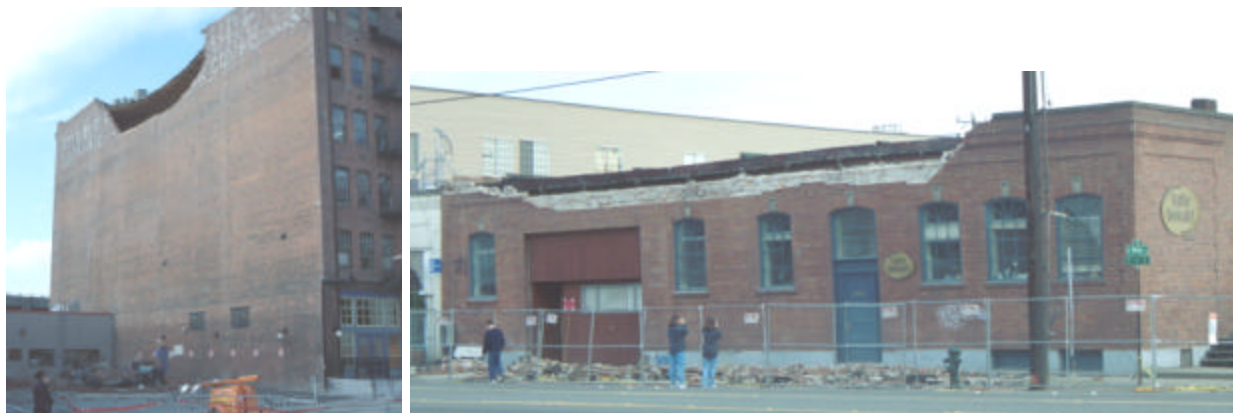
Figure 6. URM bearing wall structures with partial loss of wall.

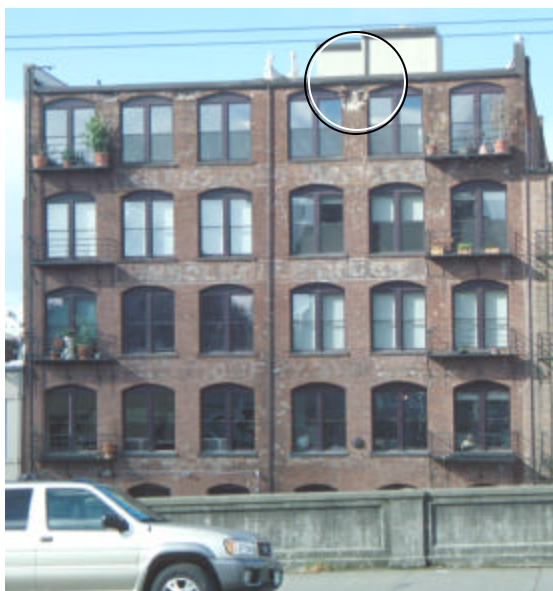
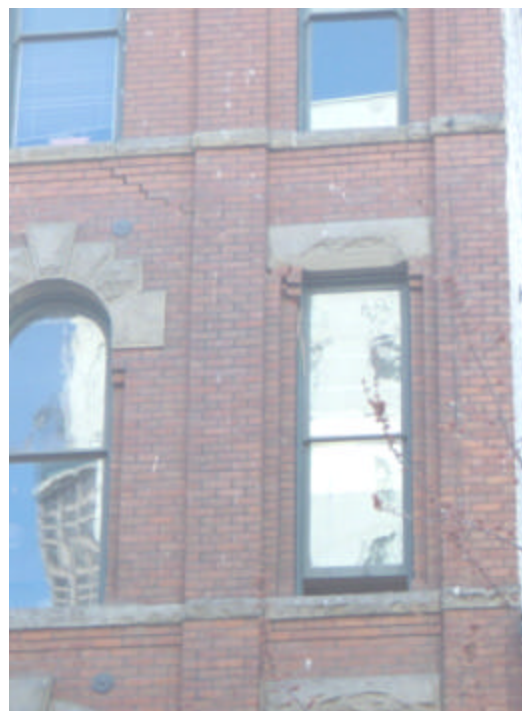
Figure 7. Damage in URM walls with masonry openings.

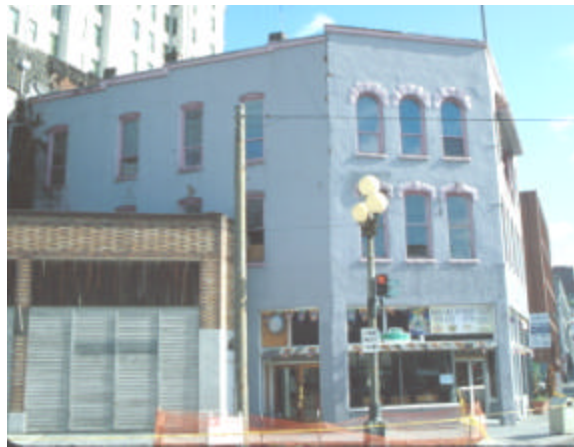
Figure 8. Corner separation perhaps due to flexible floor-diaphragm connections.

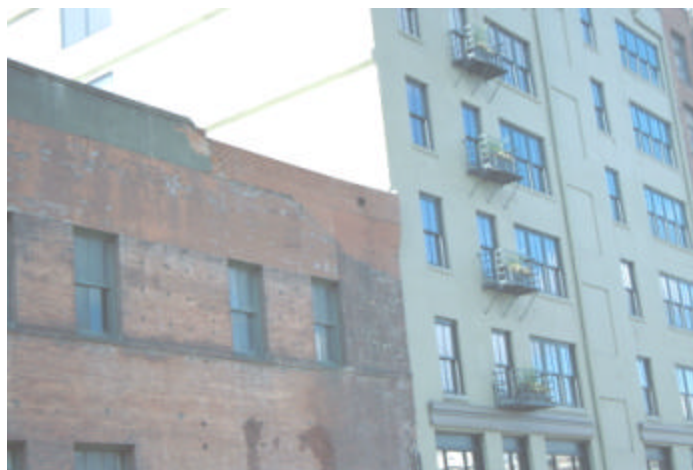
Figure 9. Parapet and wall damage due to pounding.

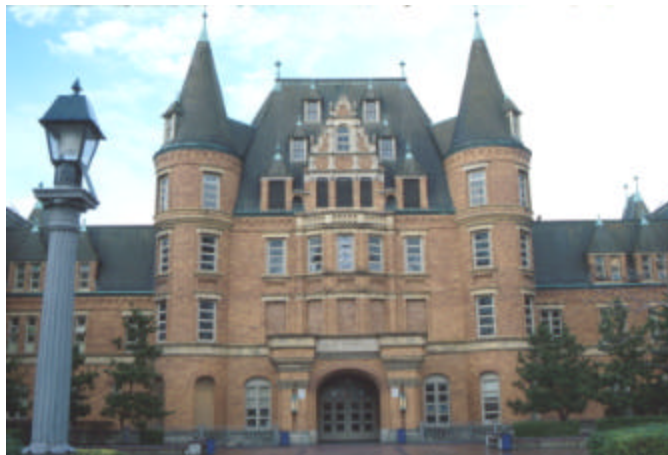
Downtown Tacoma was observed with little damage found in new or older construction. The buildings shown in Figure 10 are situated on the west side of Tacoma Avenue, which runs near the waterfront at Commencement Bay. No signs of external damage to these structures were noted. Figure 11 shows Stadium High School, which was originally constructed in 1891 as a luxury hotel. The building custodian indicated that a stone cap on a spire fell off during shaking and punched through the roof below. No other damage was found.

Figure 11. Stadium High School in Tacoma. Constructed in 1891.

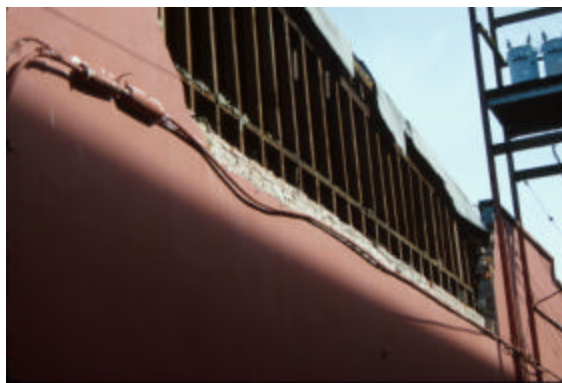
Although not as extensive as Seattle, downtown Olympia did have some significantly damaged structures. The most prominent was that of the state capitol building dome. In Olympia (including the capitol campus), 5 buildings were red-tagged and 45 were yellow-tagged. As with Seattle, a number of older URM structures sustained parapet or partial wall collapse (Figure 12).

Figure 12. Partial wall collapse of URM building on Capitol Way in Olympia.

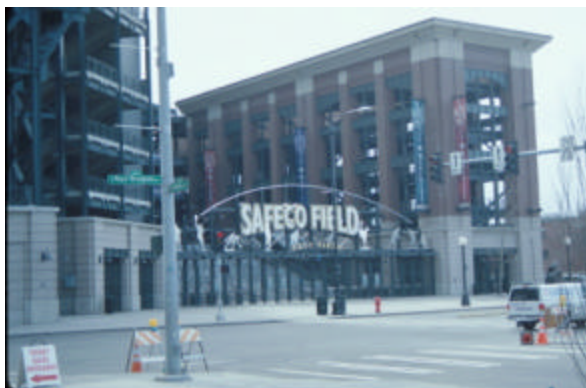
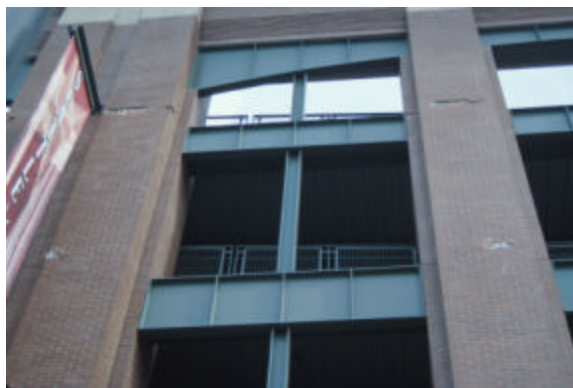
Figure 13. Safeco Field (Seattle).

During the investigation activity, a number of new buildings were visited in which little or no damage was apparent. Figure 13 shows the recently completed Safeco field near downtown Seattle. The photo shows the pedestrian ramps that serve the stadium seating. The ramps are constructed of structural steel with brick veneer. There was some cracking and spalling noted in the veneer as can be seen in the figure. However, the spalling appears to have occurred at an expansion joint. Consequently, it was not possible to determine if the spalling was a pre-existing condition caused by brick expansion or was caused by the earthquake.

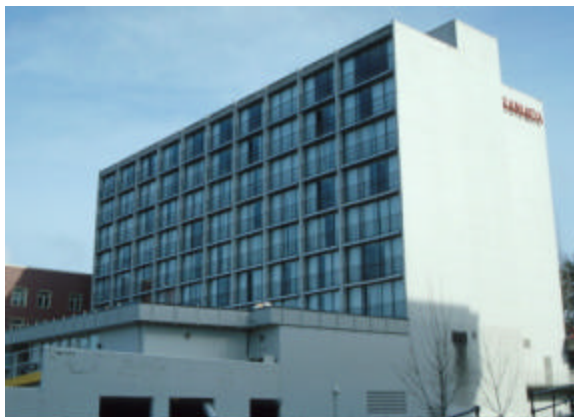
Figure 15. Ramada Inn in downtown Olympia on Capitol Way.

Figure 15 shows a multistory concrete masonry hotel located in downtown Olympia near the capitol building. It appeared that the masonry provides both the lateral and gravity load resistance for the structure (and so is likely reinforced). This is based on exterior observation and is unconfirmed. Minor cracking was noted in the slab-wall connections at some of the balconies, but no significant distress was noted on the exterior walls.

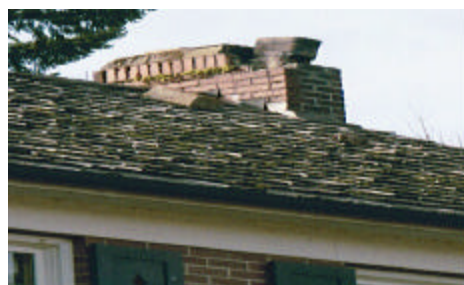
Lack of maintenance also appeared to have contributed to some of the chimney failures. In most observed failures the chimneys appeared to have pre-existing cracks and, in some cases, vegetation was observed growing out of the mortar joints (Figure 19). Further, many of these poorly maintained chimneys were constructed over 80 years ago, and were thus likely constructed with sand-lime mortar since their construction preceded the widespread use of portland cement in mortar. The combination of poor maintenance, weak mortar, and lack of reinforcement and ties made these older unreinforced chimneys particularly vulnerable to earthquake damage.

Figure 19. Vegetation growing on damaged chimney.

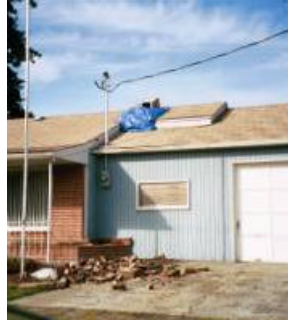
Newspaper reports indicated that there was widespread chimney damage in residential structures throughout the Puget Sound area because of the earthquake. The disaster investigation team focused on the residential areas around Olympia. Typical examples of chimney failures encountered are shown in Figure 19 through Figure 21. The failures were confined to unreinforced chimneys, constructed without reinforcement and ties that are required by modern codes.

Figure 20. Chimney collapse.

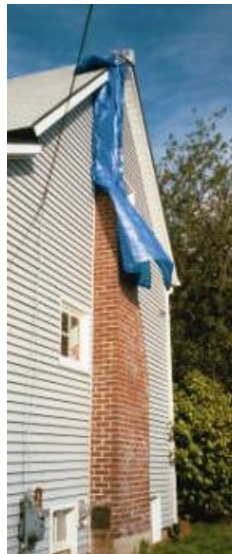
The team observed, in several areas, that the chimneys of residences on one side of the street experienced significant damage, while those chimneys on the other side of the street exhibited no observable damage. This difference in performance was likely due to the differences in the construction methods used from one area to another. For example, Mr. Gary Rust of Mutual Materials was able to point out chimneys that were known to be constructed and detailed in accordance with the 1997 UBC (Figure 22). None of these newer chimneys were observed to be damaged. As an example of the differences in the performance of chimneys in a region the damaged chimney shown in Figure 21 was across the street from the undamaged chimney shown in Figure 22. The unreinforced chimney collapsed while the properly constructed and detailed chimney showed no signs of damage.

Figure 21. Partial chimney collapse. No reinforcement or ties were found.

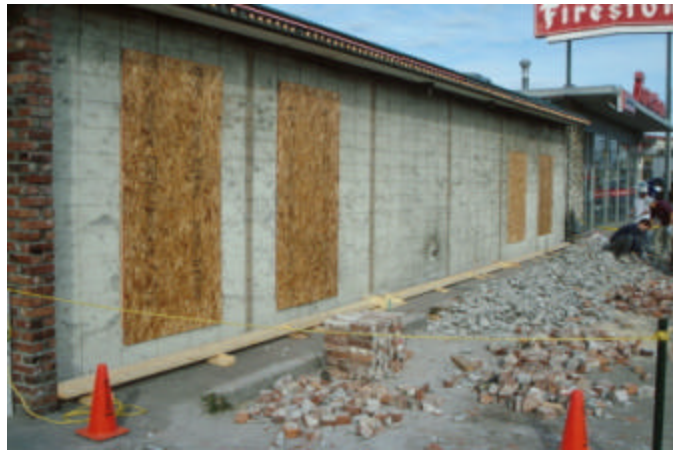
Two cases of veneer failure to commercial structures were located. The first was in the City of Renton on State Road 167. Figure 23 shows the single story structure that contains a restaurant. The workers at the site indicated that the veneer had pulled away from the back-up concrete masonry (CMU) as a result of the earthquake, but had not completely collapsed. The photo shows the veneer after it had been pulled off of the surface for repair. It appeared from observation of the removed brick that the wall ties were not installed properly. Corrugated ties were found at the ends of the wall panel, but no anchorage was found in the interior of the panel. Furthermore, the corrugated ties had been embedded in bed joints but not attached to the existing CMU backup wall.

Figure 23. Veneer Failure in Renton, WA.

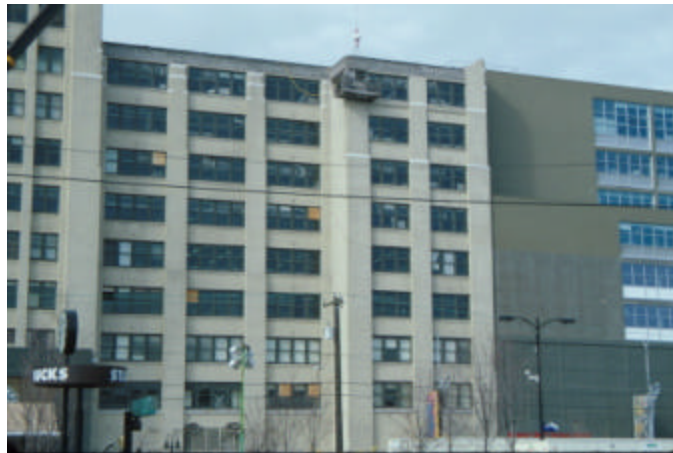
The second commercial veneer failure was observed on the recently retrofitted Starbucks corporate headquarters in Seattle. Figure 24 shows the north wing of the building during demolition and repair. The figure shows the layer of brick at the roofline that has pulled away from the underlying concrete frame. Access was not allowed to the building, so it is not clear if the veneer was properly tied to the frame. In addition, it was observed that the parapet was constructed with two wythes. This

changes to single wythe at the top of the upper-most concrete spandrel beam. It is possible that the parapet failed first, pulling some of the veneer from the face of the concrete beam.

Figure 24. Veneer failure at Starbucks Building in Seattle, WA.
