TMS
DISASTER INVESTIGATION REPORT

***PERFORMANCE OF MASONRY STRUCTURES
IN THE NISQUALLY, WASHINGTON
EARTHQUAKE OF
FEBRUARY 28, 2001***

**A Report by the Disaster Investigation
Reconnaissance Team of TMS**

December 2001

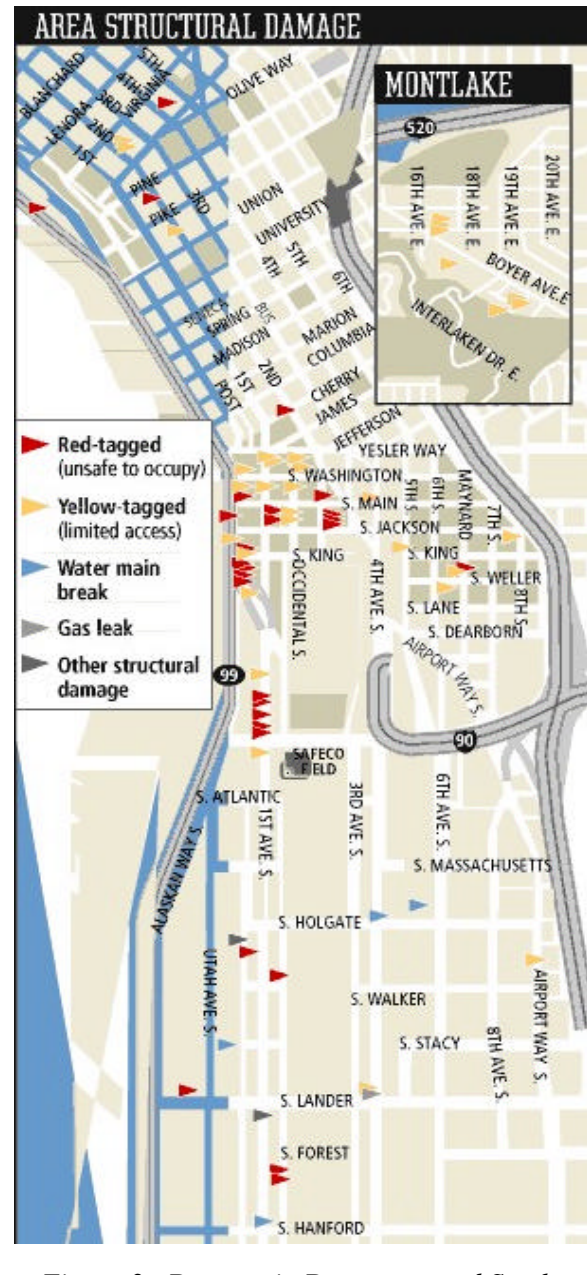
The significant damage observed in the Seattle area was confined to the downtown area, which has older URM structures founded on saturated fill material. The Pioneer Square area in downtown Seattle is located just adjacent to the waterfront (Figure 3). The area was filled and developed in the late 1800's and early 1900's. Consequently, there is a concentration of 2- to 5- story residential and commercial URM buildings in Pioneer Square and south downtown (SoDo) Seattle. A few of the structures observed carried historical markers indicating construction dates near the turn of the century. Seattle does not have mandatory strengthening requirements for URM buildings. However, several of the URM buildings observed appeared to have been strengthened with roof and floor ties as evidenced by regular patterns of anchor ends visible on the exterior (Figure 4).

Figure 3. Damage in Downtown and South Downtown (SoDo) Seattle (Seattle Post-Intelligencer, Saturday, March 3, 2001).

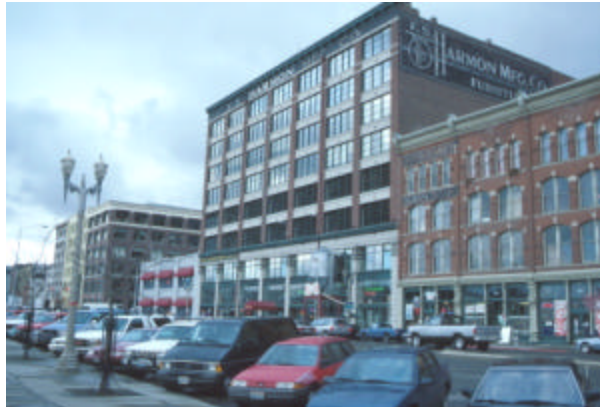
Downtown Tacoma was observed with little damage found in new or older construction. The buildings shown in Figure 10 are situated on the west side of Tacoma Avenue, which runs near the waterfront at Commencement Bay. No signs of external damage to these structures were noted. Figure 11 shows Stadium High School, which was originally constructed in 1891 as a luxury hotel. The building custodian indicated that a stone cap on a spire fell off during shaking and punched through the roof below. No other damage was found.

Figure 10. Older undamaged URM structures along Tacoma Avenue in Tacoma, WA.

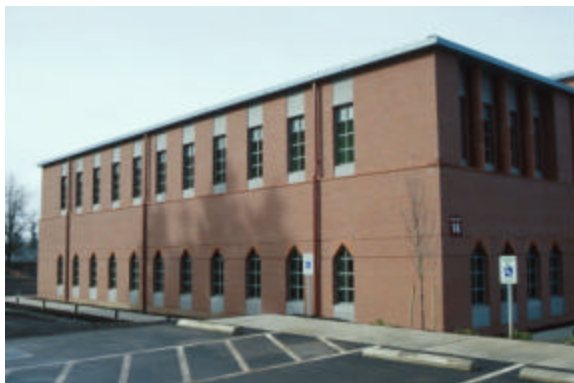
Figure 14 shows an institutional structure with clay brick veneer over a structural steel frame. This structure is located in Lacey, a suburb of Olympia located approximately 3 miles southeast of downtown Olympia.

Figure 14. St. Martin's College Library new brick veneer building (Lacey).

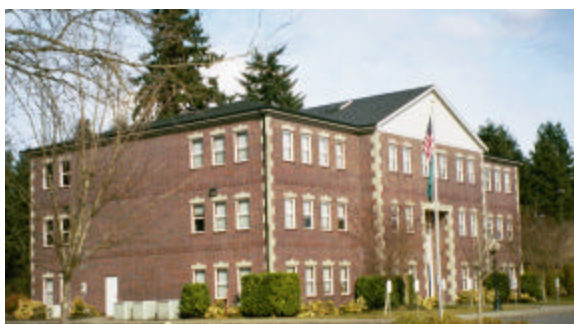
Figure 16 shows a new three-story brick veneer on wood frame building located in Olympia. The building was constructed using 22 gauge galvanized metal ties in the first story and seismic ties in the remaining stories. No signs of damage to this structure were noted.

Figure 16. Three-story brick veneer on wood frame structure (Olympia).

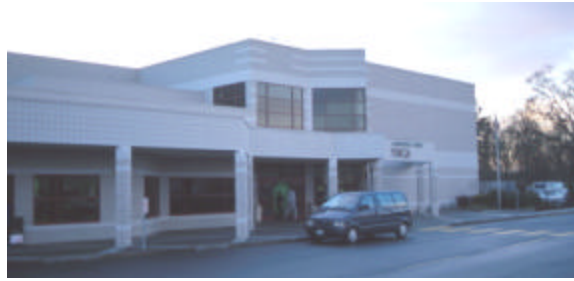
Figure 17 shows a new YMCA facility located in Tacoma constructed of reinforced concrete masonry where no damage was noted.

Figure 17. Lakewood Family YMCA (Tacoma).

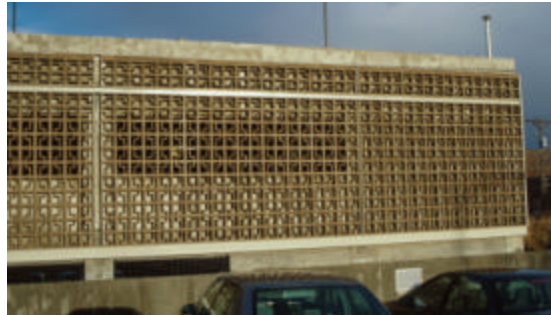
Figure 18 shows what appeared to be a cast-in-place, post-tensioned concrete parking garage. The exterior of the garage was covered with concrete masonry screen wall that did not appear to be tied to the structure, except at its edges. The screen wall did not have any visible signs of damage.

Figure 18. Concrete masonry screen wall on parking garage (Tacoma).

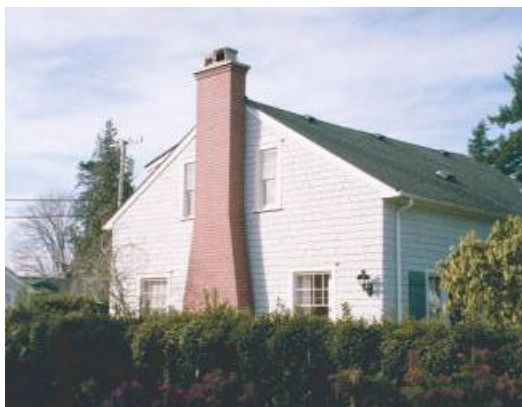
The team observed, in several areas, that the chimneys of residences on one side of the street experienced significant damage, while those chimneys on the other side of the street exhibited no observable damage. This difference in performance was likely due to the differences in the construction methods used from one area to another. For example, Mr. Gary Rust of Mutual Materials was able to point out chimneys that were known to be constructed and detailed in accordance with the 1997 UBC (Figure 22). None of these newer chimneys were observed to be damaged. As an example of the differences in the performance of chimneys in a region the damaged chimney shown in Figure 21 was across the street from the undamaged chimney shown in Figure 22. The unreinforced chimney collapsed while the properly constructed and detailed chimney showed no signs of damage.

Figure 22. Chimney across the street from that shown in Figure 21.
