Resistance of Exterior Walls to High Velocity Projectiles

ABSTRACT

This paper contains the findings of an experimental evaluation on the behavior of common exterior wall assemblies found in residential construction when impacted by bullets fired from a wide variety of firearms of different caliber. Three basic types of exterior wall finishes were evaluated: stucco, vinyl siding, and masonry. All the walls were constructed in wood frame, with the exception of one wall, which was constructed using 140 mm hollow concrete blocks as the back-up system. The findings of the study have demonstrated that a bullet fired from a .22 caliber firearm, a relatively small and readily available firearm, can consecutively penetrate two walls constructed in wood frame and vinyl siding. Walls constructed with a 90 mm masonry veneer however, are effective in stopping bullets fired from a 9 mm submachine gun. These preliminary findings are intended to assist both engineers and architects in choosing the appropriate wall materials for structures where gun fire may occur.

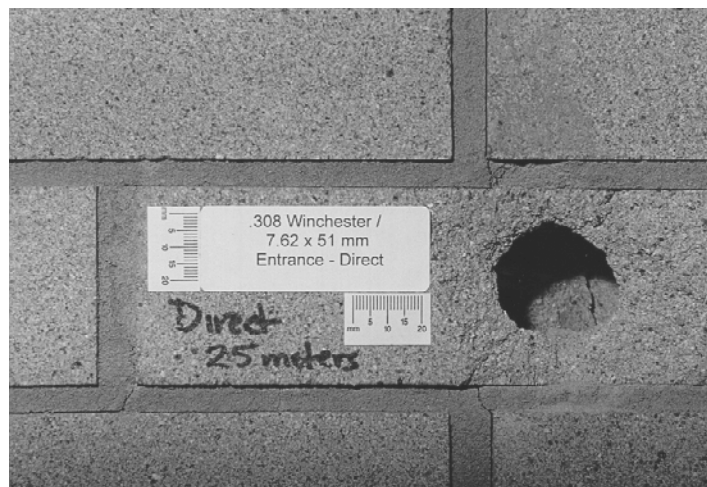
The .308 Winchester bullet produced removed a chip approximate 80 mm wide by 55 mm high from the brick. In addition, a 35 mm diameter hole was produced to a depth of about two thirds the brick thickness. The mortar was cracked around the perimeter of the brick.

Figure 3 - Damage to clay brick caused by .308 Winchester

The .308 Winchester bullet fired at a 45 degree angle chipped a out a piece approximately 100 mm wide by 55 mm high from the front of the brick. The bullet created a circular hole approximately 50 mm in diameter and became lodged in the center of the brick. This impact also fractured the brick in many places that were not visible from the outside of the wall. Figure 3 shows the damage caused by the .308 Winchester upon direct impact.

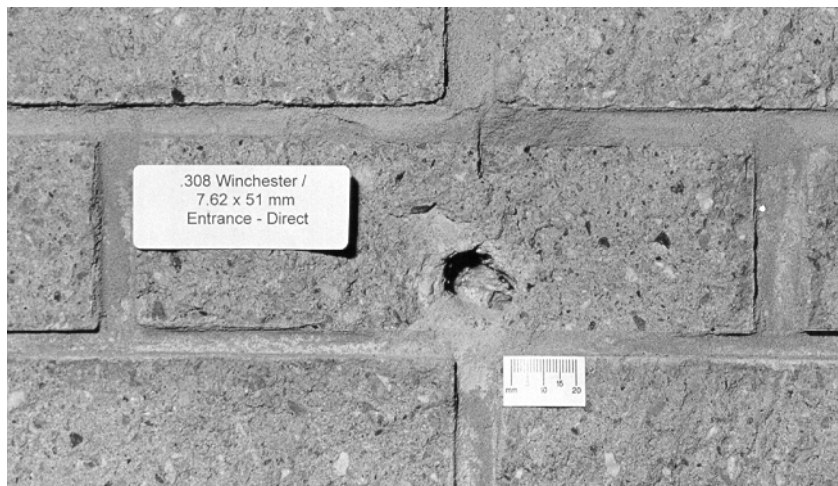
The .308 Winchester bullet removed a region approximately 100 mm wide by 55 mm high. The hole was 25 mm by 20 mm to a depth of approximately half the brick thickness. This damage is shown in Figure 4.

Figure 4 - Damage to concrete brick caused by .308 Winchester

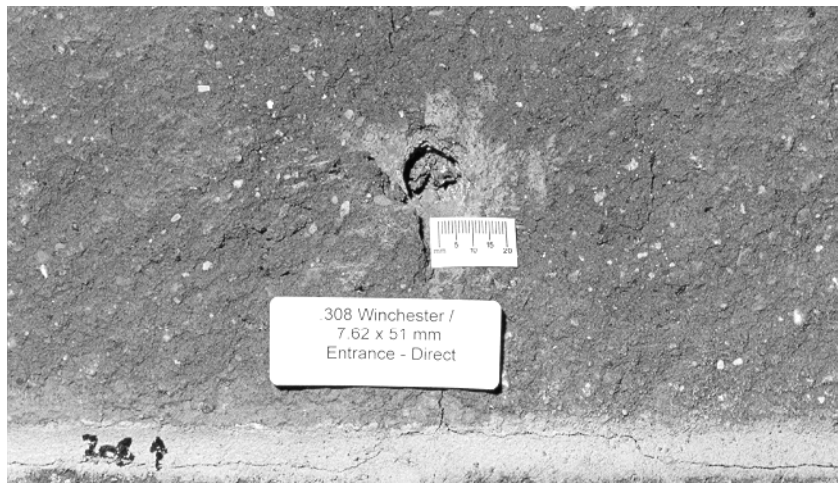
The .308 Winchester bullet displaced a portion of the block approximately 40 mm in diameter. It left a hole approximately 21 mm in diameter and 13 deep as shown in Figure 5. The brick was also cracked from top to bottom with the fracture plane running through the hole.

.22 Long Rifle	Chip in brick
.223 Remington	Hole in brick
7mm Remington Magnum	Hole in brick with cracking of block and mortar
.308 Winchester	Hole in brick with cracking of block and mortar

Figure 5 - Damage to red concrete brick caused by .308 Winchester
